[Description of the hazards for visitors, climbers and the houses at the Hellen area in Jøssingfjord]

Titania as

24. May 2013

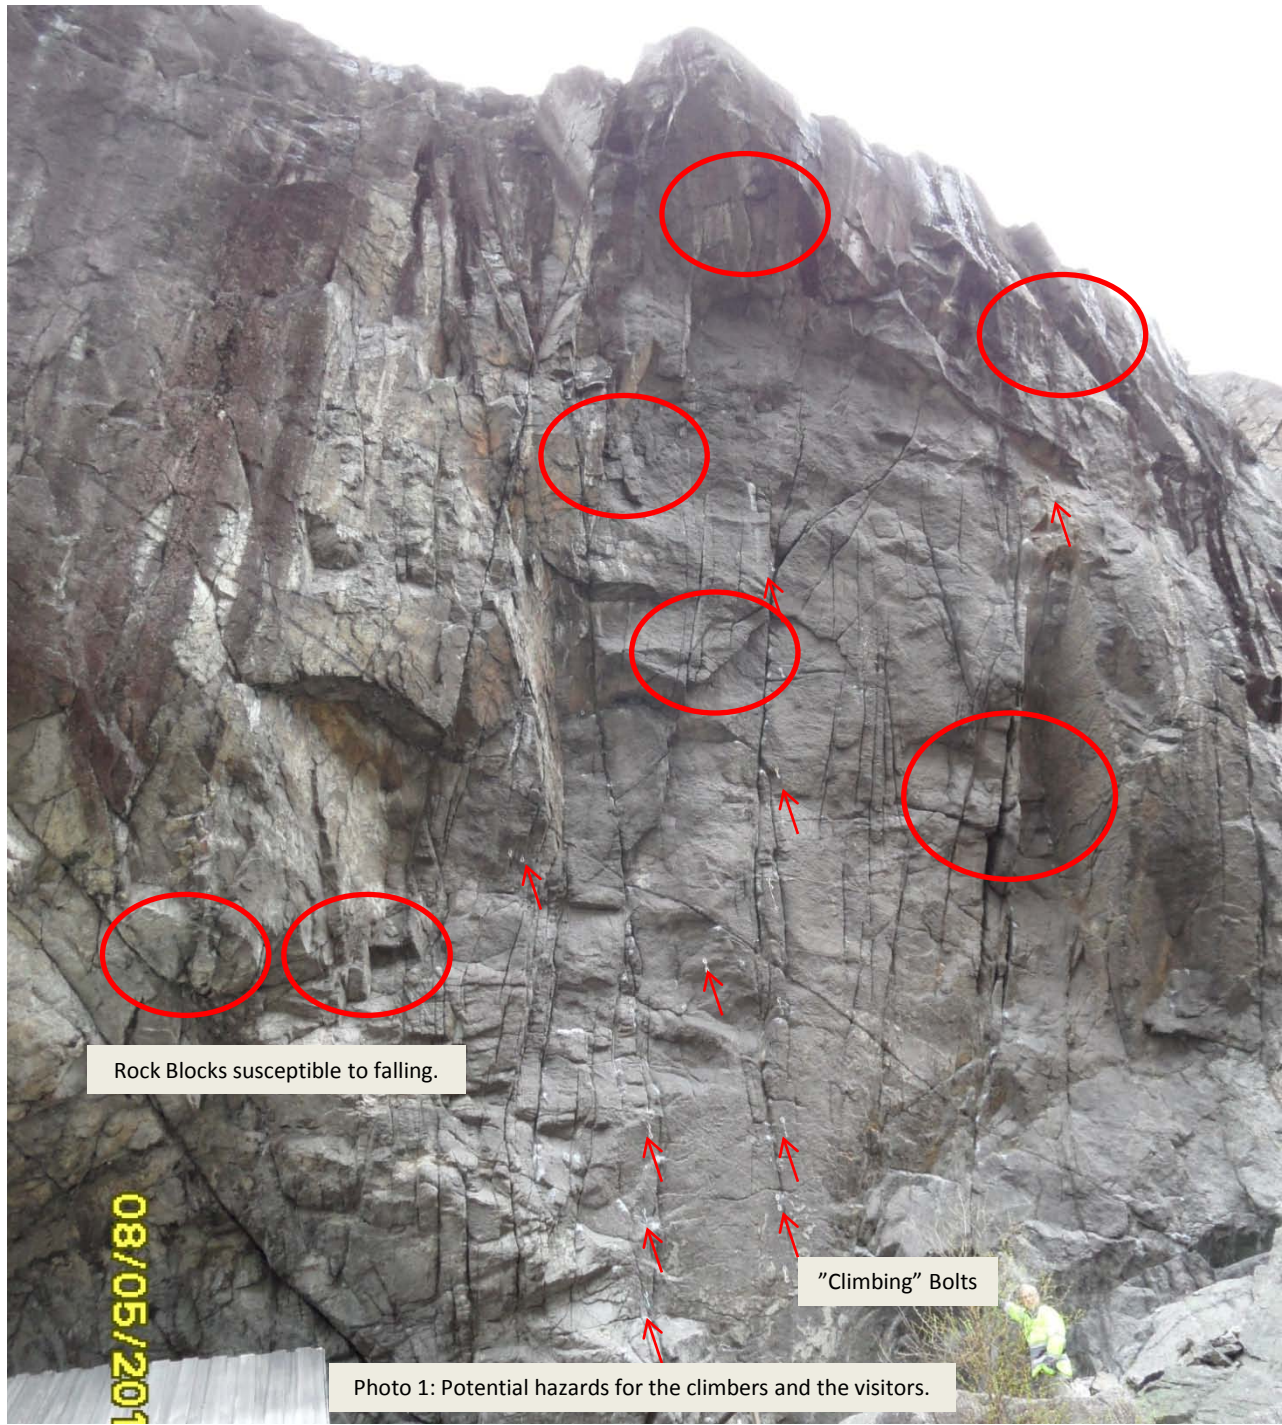
The disintegrated rock along the hanging wall is susceptible to rock falls. As it can be seen in figures 1, 2 and 3, there are many parts of the wall, where short or longer fractures, are defining rock blocks that are susceptible to rock falls especially during the thawing periods. The periodical freezing-thawing cycles are disintegrated the rock even more, and rock falls could happened at any time without warning. The surrounding area is full of rock blocks that fall in the past. What happened in the past, it will happen in the future, as the geotechnical setting is still the same. The time that a rock fall will happen is impossible to predict, but the most likely period is the spring period.

Rock Blocks susceptible to falling.

"Climbing" Bolts

Photo 1: Potential hazards for the climbers and the visitors.

It is recommended that the climbing activities should stop as soon as possible. The hanging wall should be cleaned by specialized climbers that will remove the loose rocks on the steep rock slope.

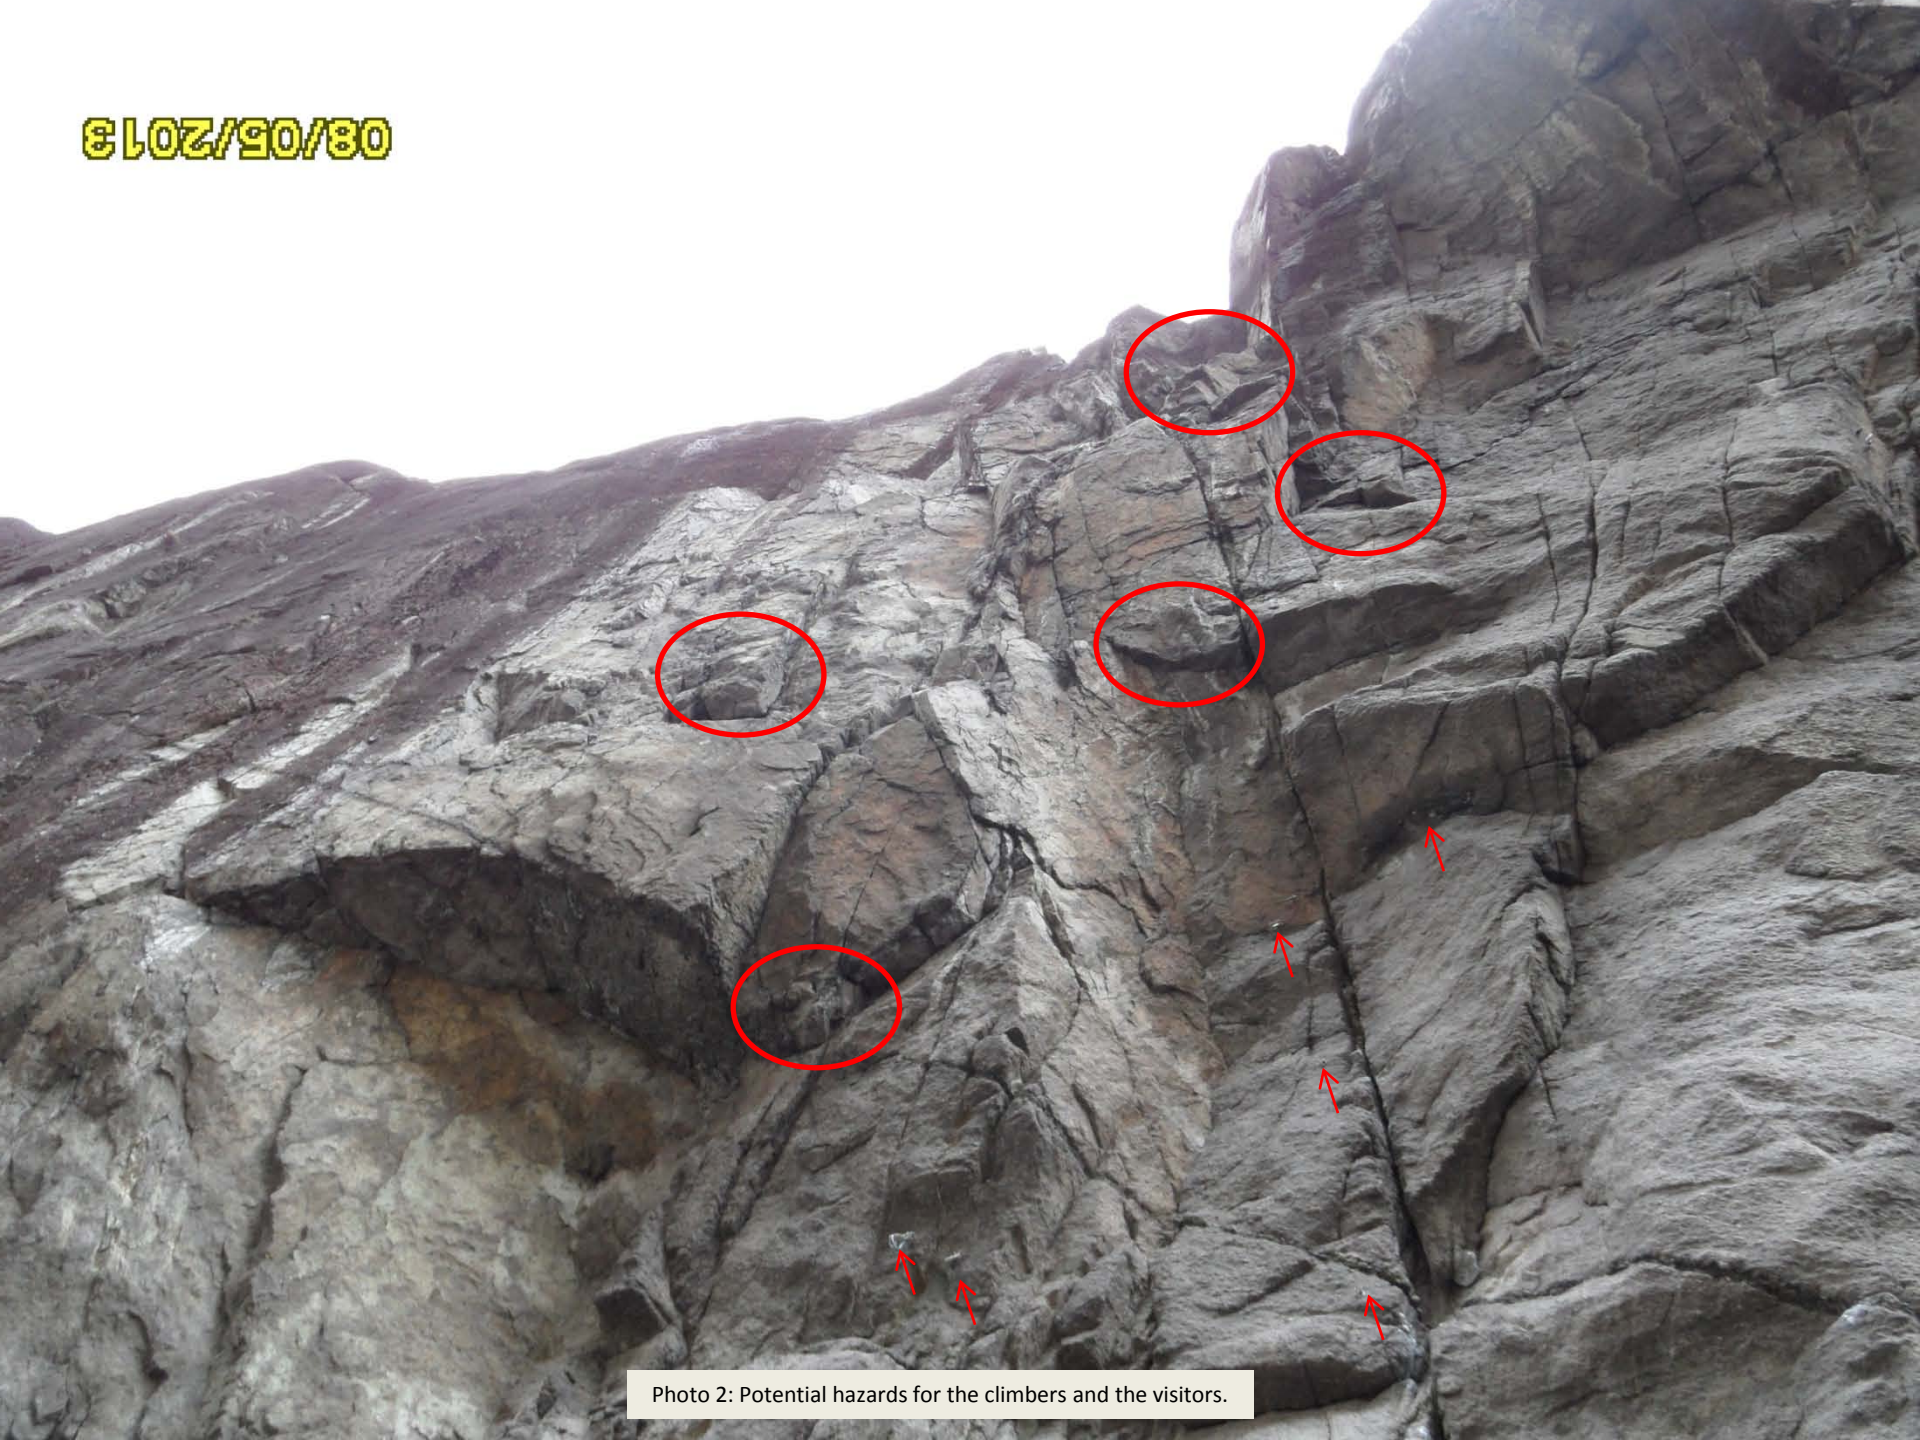
Photo 2: Potential hazards for the climbers and the visitors.

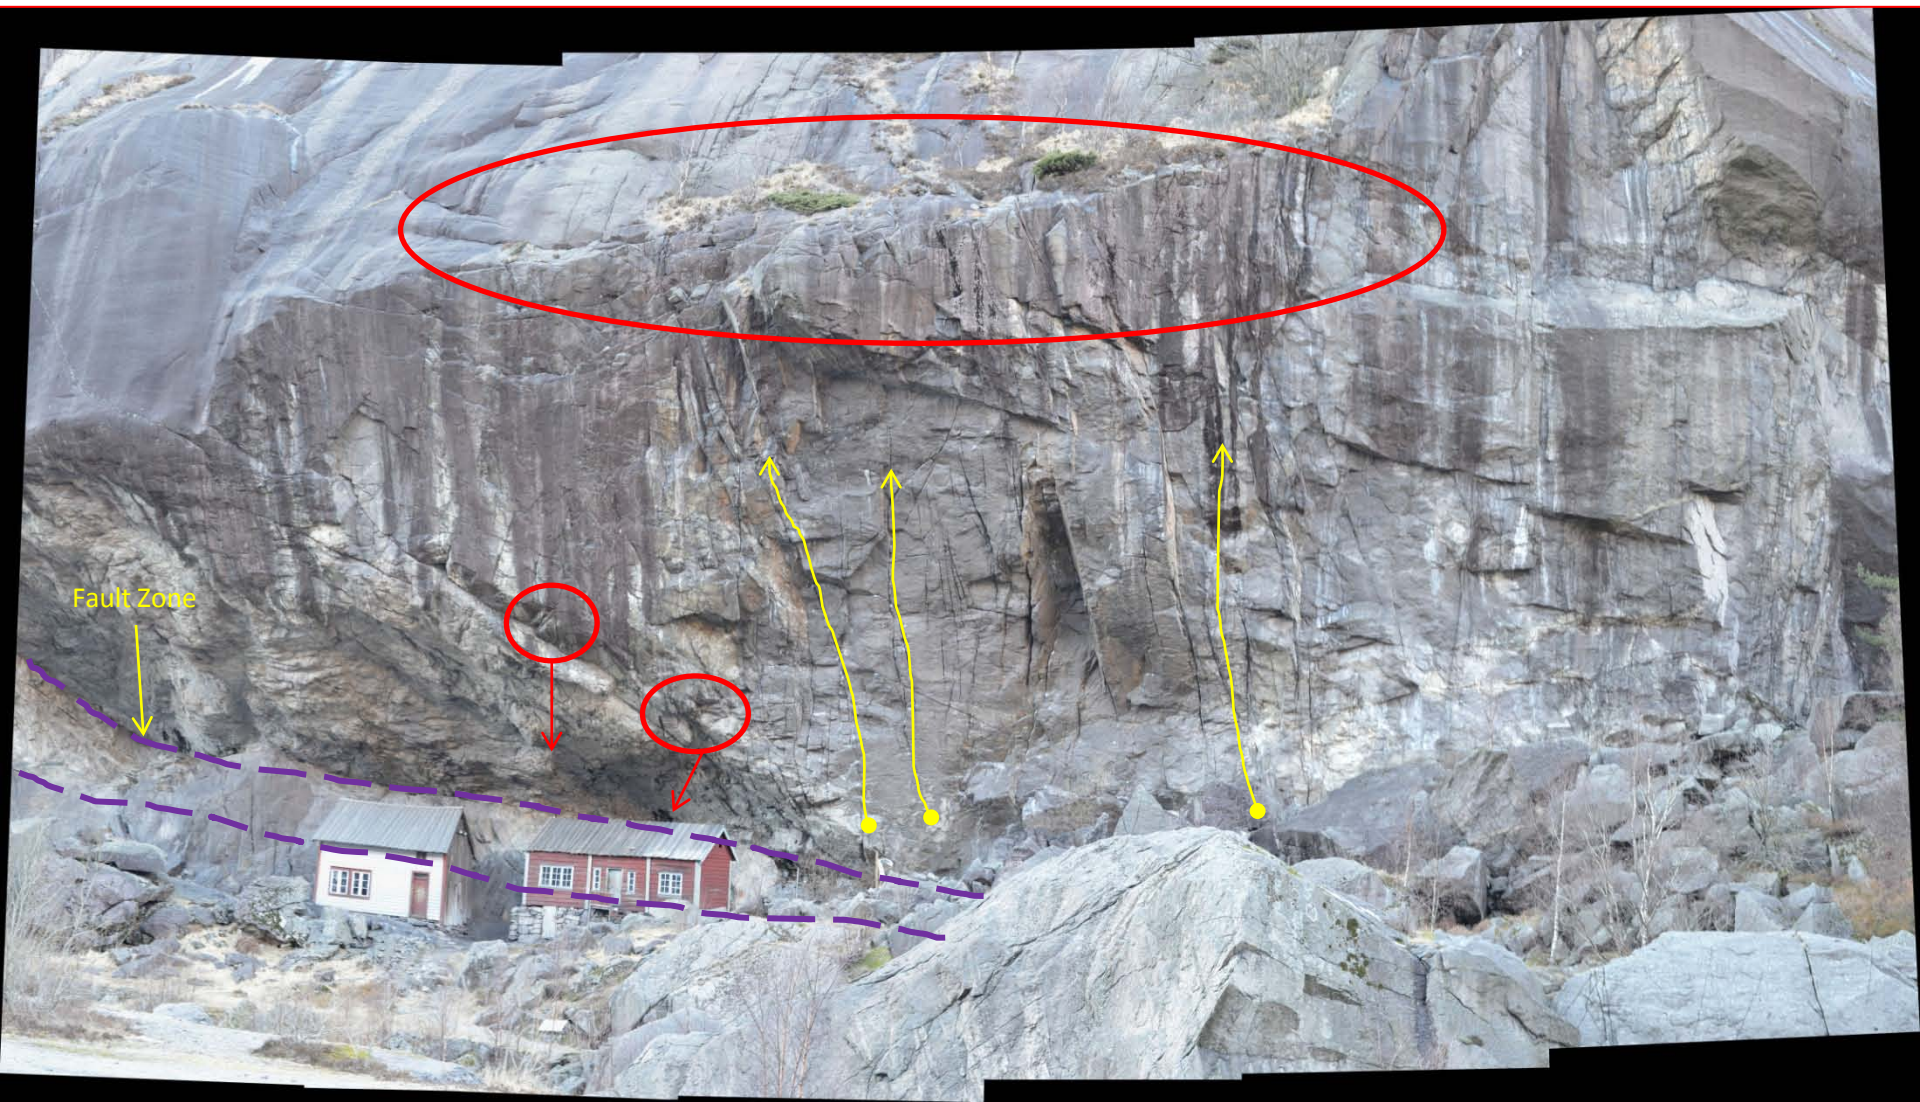
This overhanging lithologically is characterized as anorthosite, and is actually the hanging wall of a thrust fault zone. The core of the fault zone is shown in figure three. This zone is quite thick (0,5 meters or more at some places), which is a strong indication of great tectonic event that took place in the geological past. The practical meaning, is that the rock has poorer geotechnical characteristics, and is more susceptible to the forces of erosion and weathering. Actually the overhanging formation is a result of the erosion from the wind and the water.

In addition the houses which are the “core” of this sightseeing are quite vulnerable to rock falls as wall. As it can be seen in photo 3 there rock blocks that could potentially harm parts of the houses. These infrastructures are in constant danger, even if people are not visiting that place all the periods of the year.

Photo 3: Potential hazards for the climbers visitors and the houses. Possible rockfalls from the crest of the slope.
